# **2018 DAM INSPECTION REPORT FOR SILVER LAKE LEVEL CONTROL SYSTEM**

Submitted to:  
**GRAND TRAVERSE COUNTY DRAIN COMMISSION**  
2650 LaFranier Road  
Traverse City, Michigan 49686  
SLargent@grandtraverse.org

Submitted by:  
**J.E. TIFFANY AND SONS, LLC**  
1707 N. 39 Road  
Manton, MI 49663

December, 2018

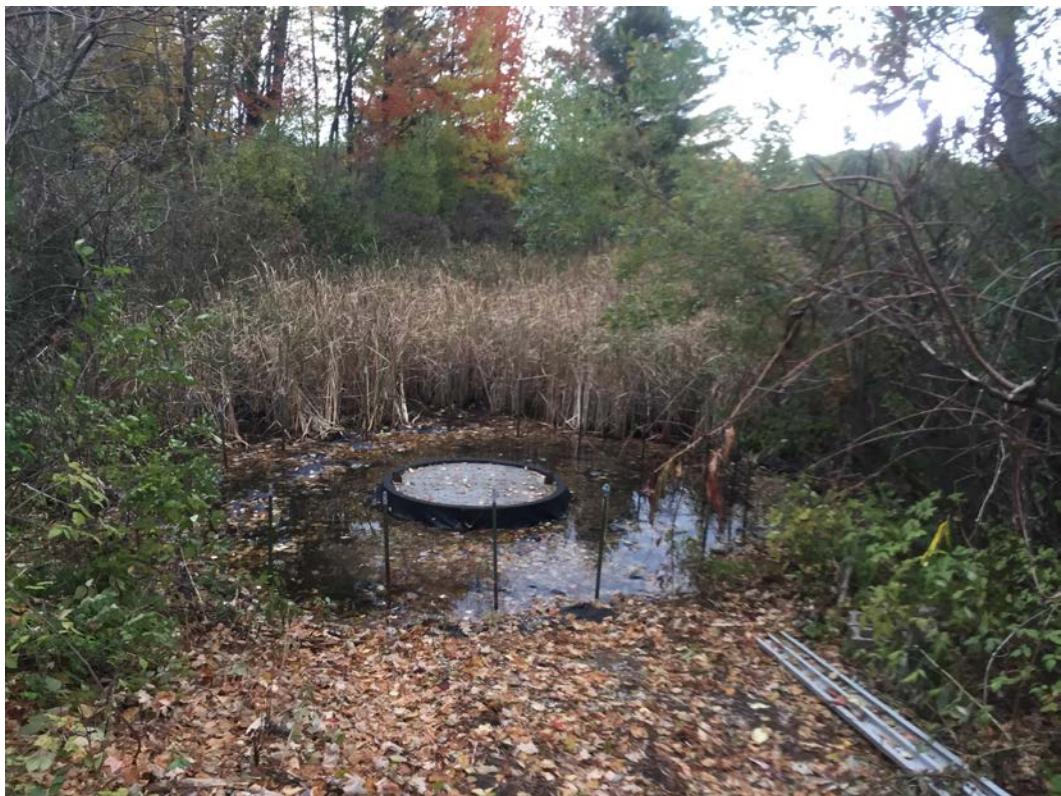
**CONCRETE STRUCTURE:** Check for erosion; location of cracking or spalling. If old or new; settlement; need for crack repairs.  
 6' dia. concrete intake/riser structure with trash rack cover. All appear to be in good condition. Vortex forms when water is significantly above the rim of the structure decreasing discharge efficiency leading to higher than necessary lake levels during periods of high runoff.

Riser/Intake Structure in Pond Connected to Silver Lake

1) Sliplining 36" dia. CSP downstream of Cox Pond \$115,000  
 2) Improvements to prevent vortex formation \$ 3,500

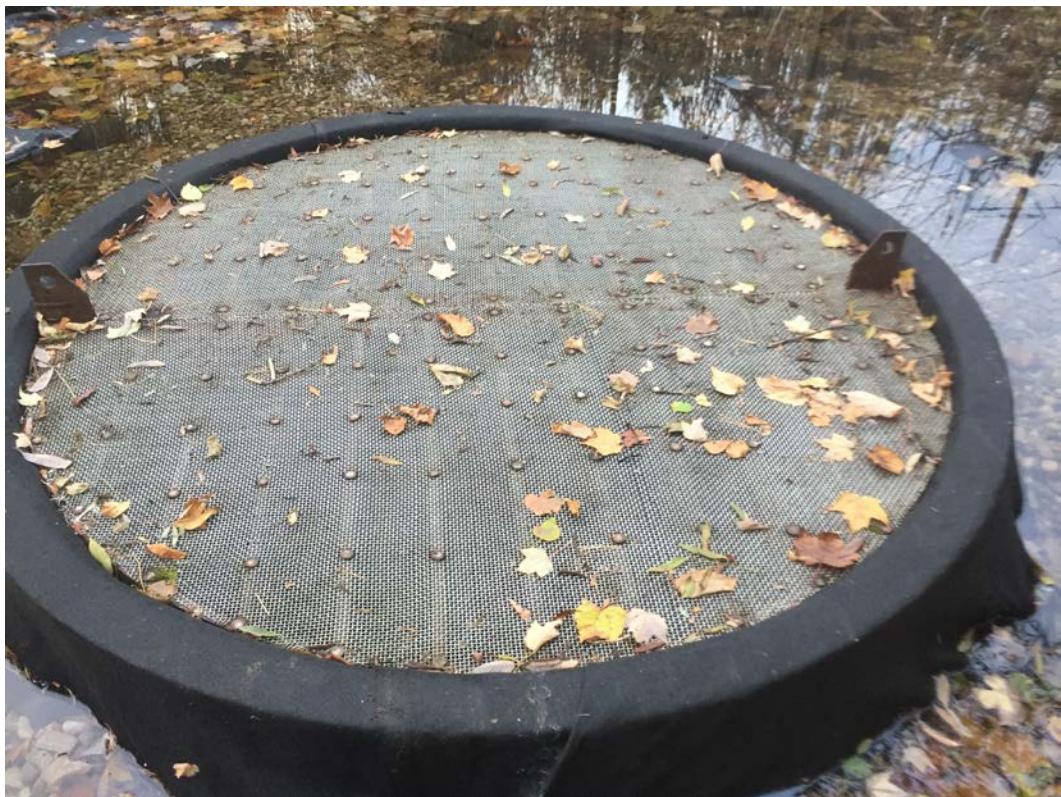
WALKWAY & RAILING: Check if in place or removed, condition, and if adequate protection provided.  N/A	TRASHRACK OR LOG BOOM: Check if operable.  Trashrack over top of concrete intake/riser structure is in good condition. Fencing/mesh is used surrounding structure to catch leaves & debris.
EMERGENCY SPILLWAY: Size, type, and condition.  N/A

Trash Rack Over Riser/Intake Structure

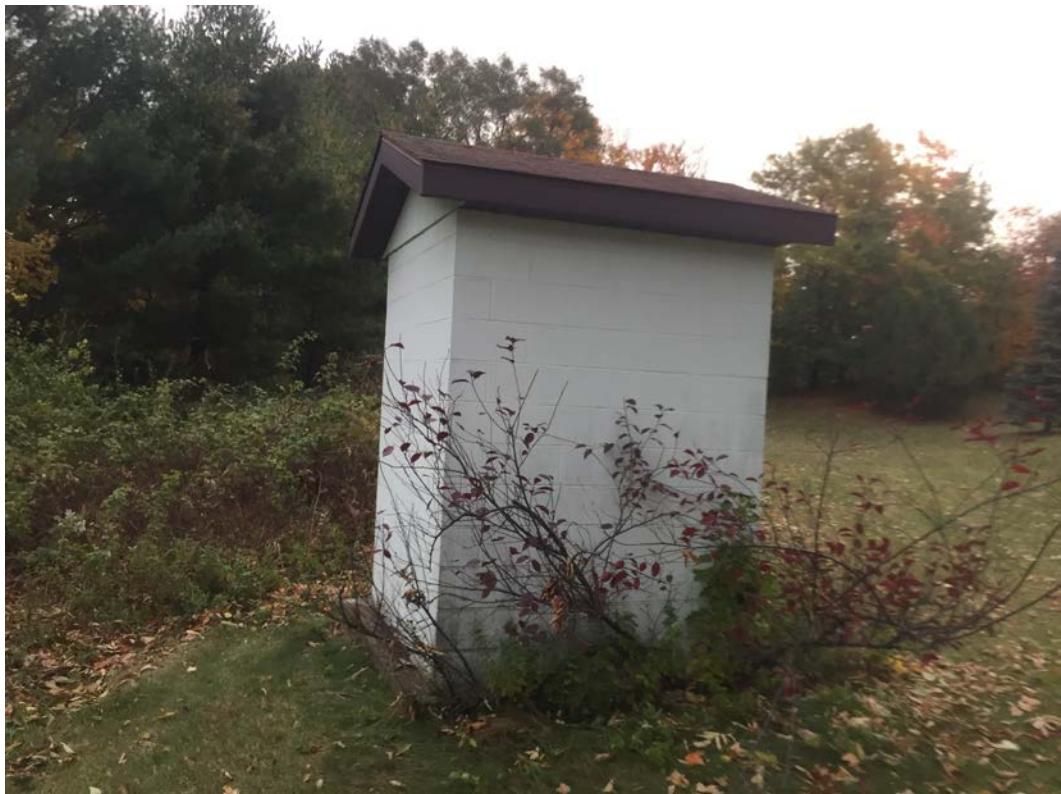
Valve House Above Discharge Piping

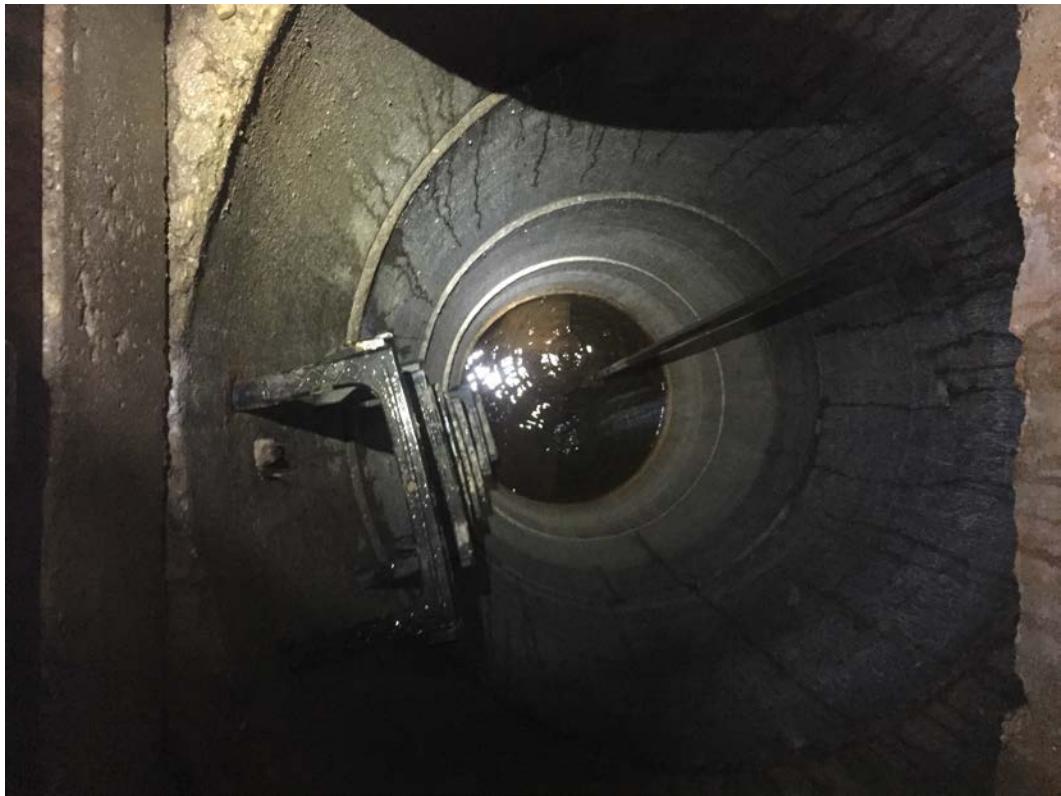
Valve Well

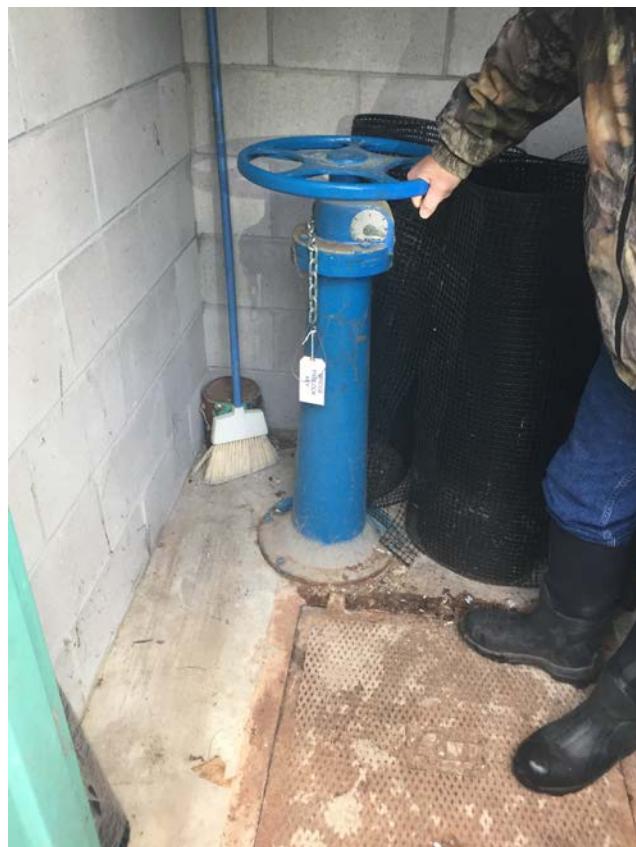
STOPLOG VALVES AND GATES (open and close to check condition): Check location of top stoplog in relation to top of riser pipe intake box or fixed crest, for leakage, and condition of stoplogs, valves and gates.  
 14" diameter butterfly valve with riser stem and operating wheel in valve building approximately 75' downstream of the intake/riser structure. Has been operated in the last year.

Valve Operator

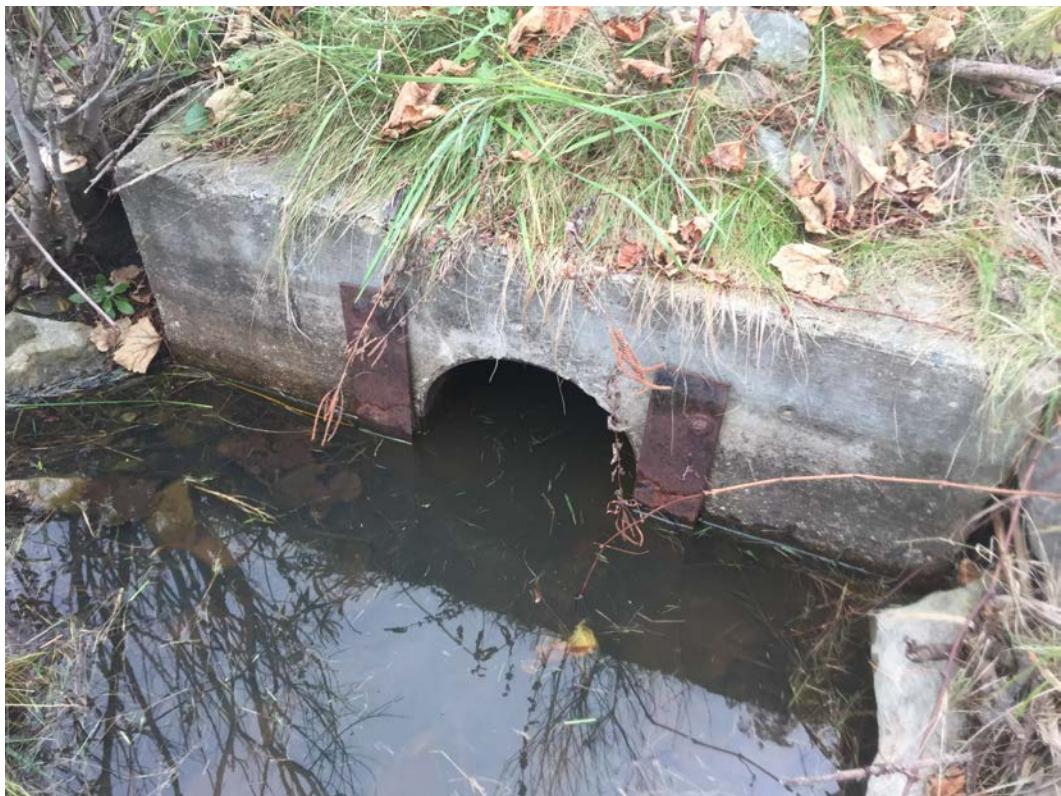
Downstream End of 14" Diameter Discharge Pipe

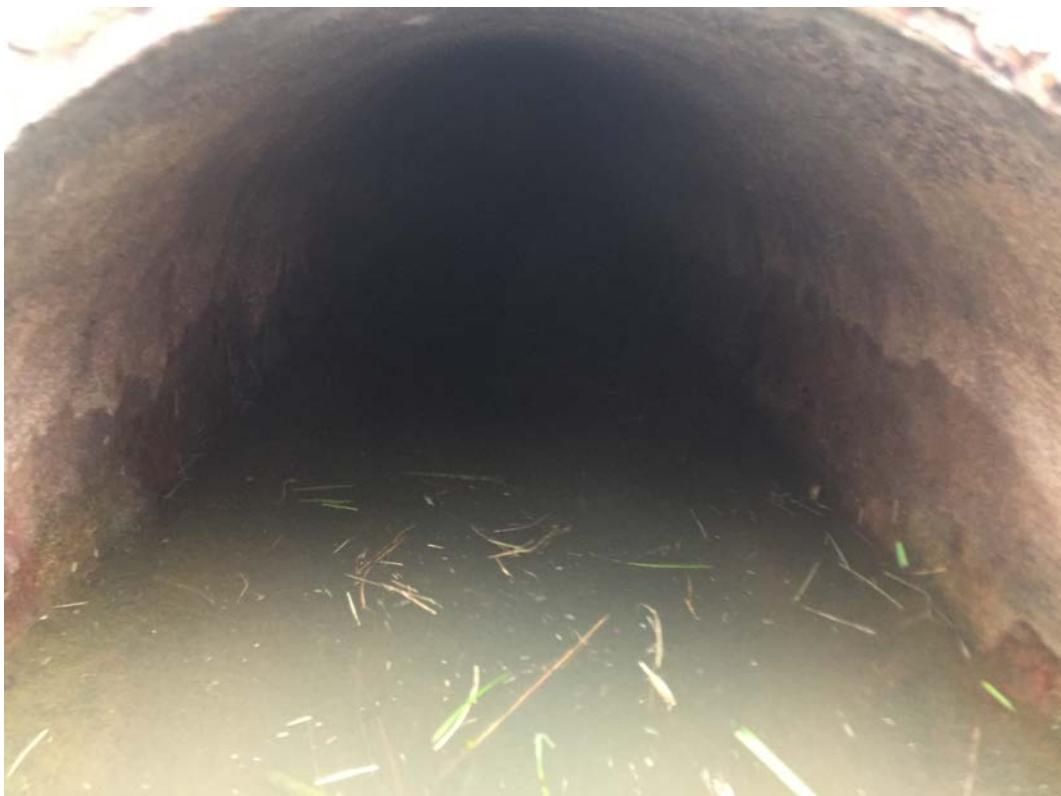
14" diameter class 50 cement lined ductile iron pipe. Video recording of pipe in last year indicates that the pipe is in good condition overall.

Interior of 14" Diameter Ductile Iron Discharge Pipe

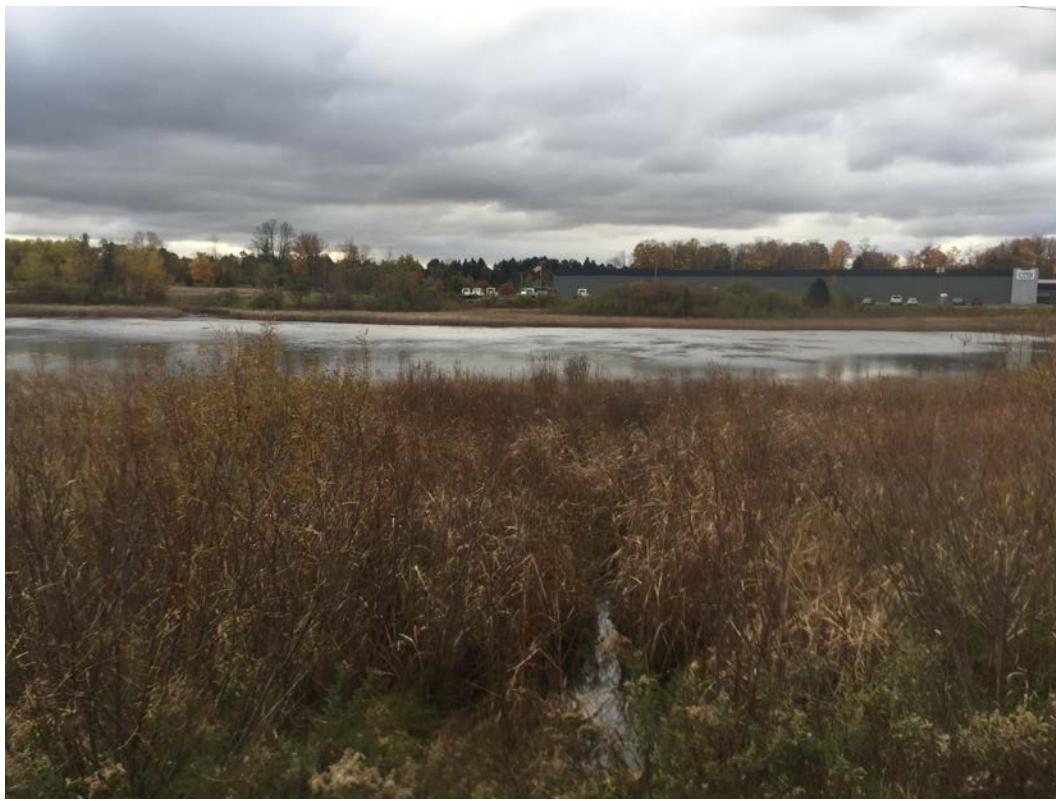
INLET	OUTLET
SIZE	Pond	Cox Pond
EXISTING CONDITION	Good	Good
EROSION	None	None
DEBRIS & OBSTRUCTIONS	None	Small shrubs and grass in outlet channel but not of significant concern at this time.
RIPRAP PROTECTION	None	Some riprap in bed of outlet channel downstream of discharge pipe.
REMARKS*	Recent project to place filter fabric and stone in bed of pond surrounding the intake/riser structure	The 36" dia. CSP downstream of the Cox Pond is failing. A sliplining project is recommended.

Channel to Cox Pond & Cox Pond Downstream of Discharge

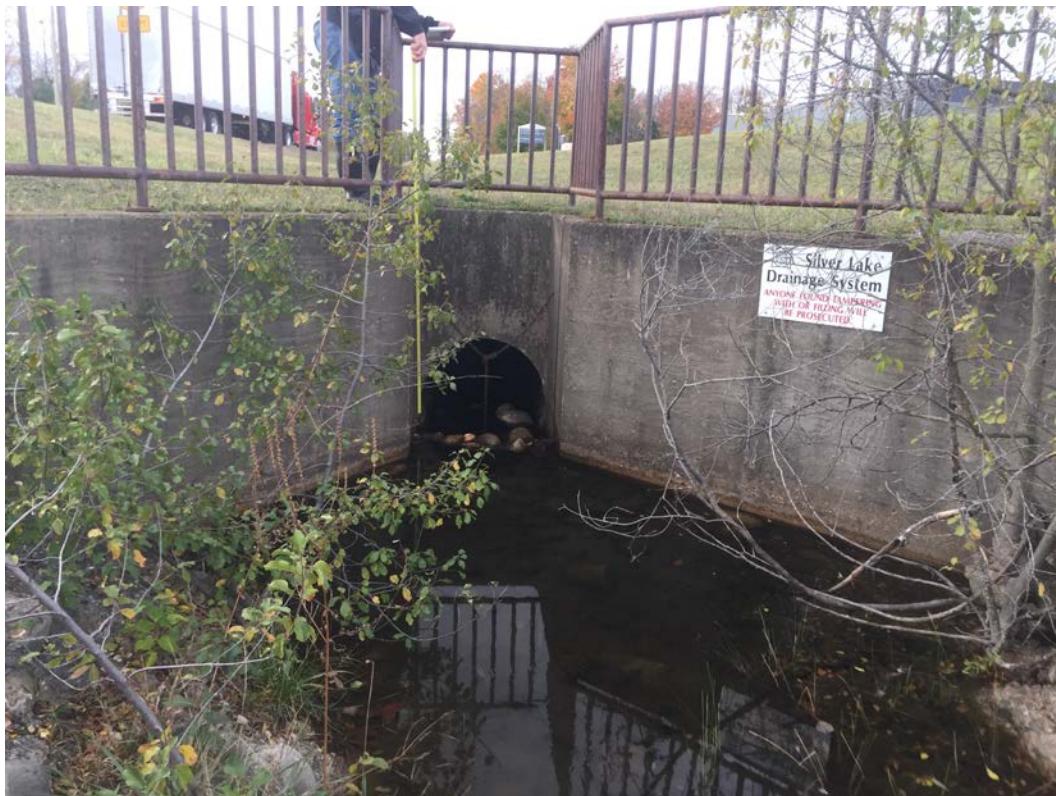
Culvert at Outlet of Cox Pond

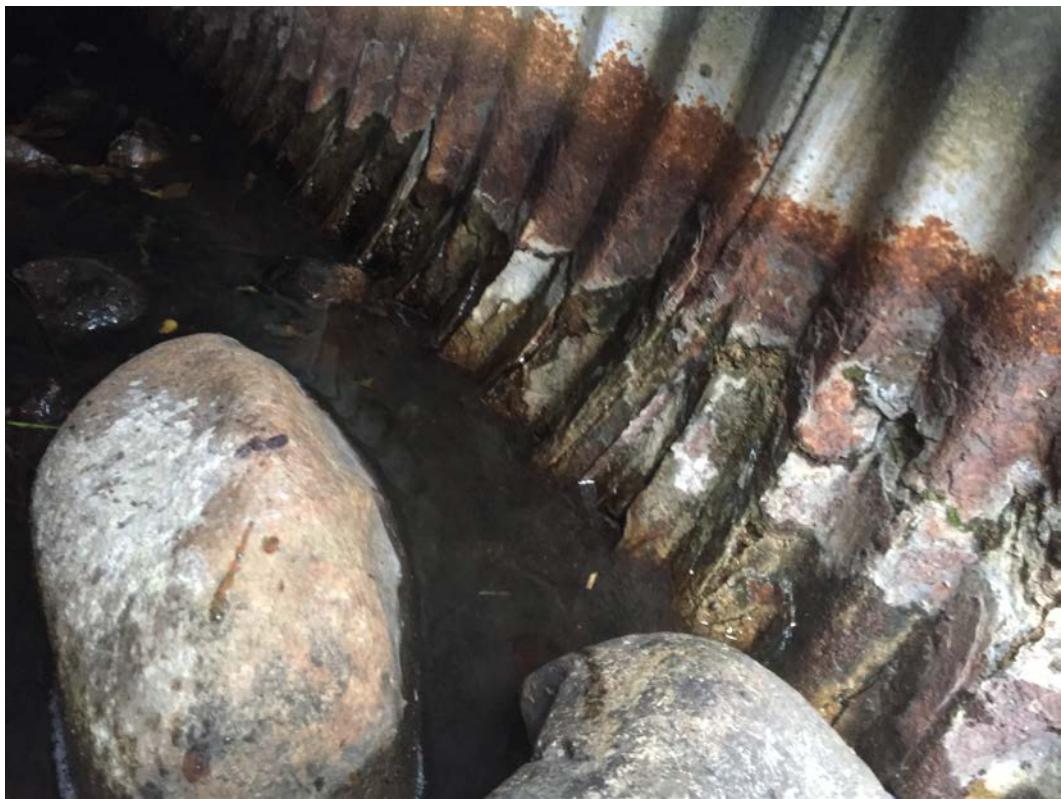
Failing Culvert Downstream of Cox Pond

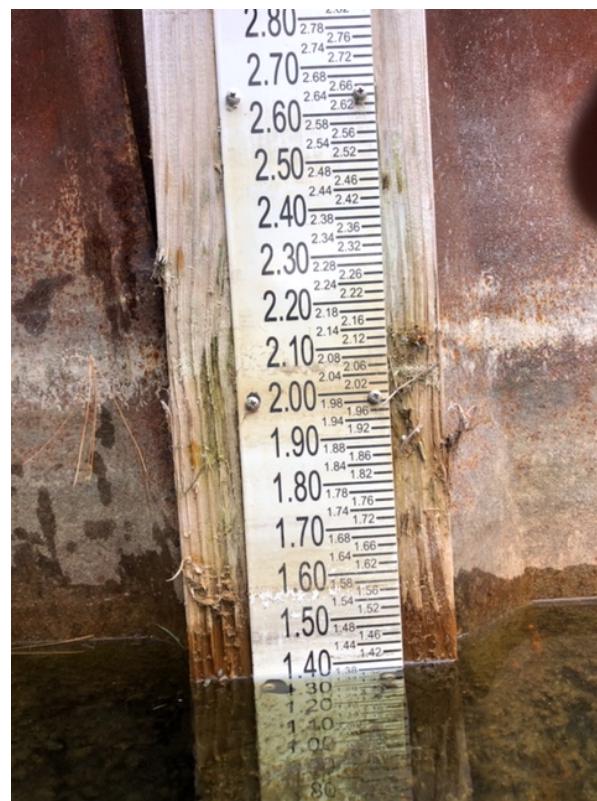
Staff Gauge in Silver Lake
